THE CHURCH OF ST MICHAEL AND ALL ANGELS, CROFT

Quinquennial Inspection Report

Diocese: Hereford

Date of Inspection: 1st August 2016

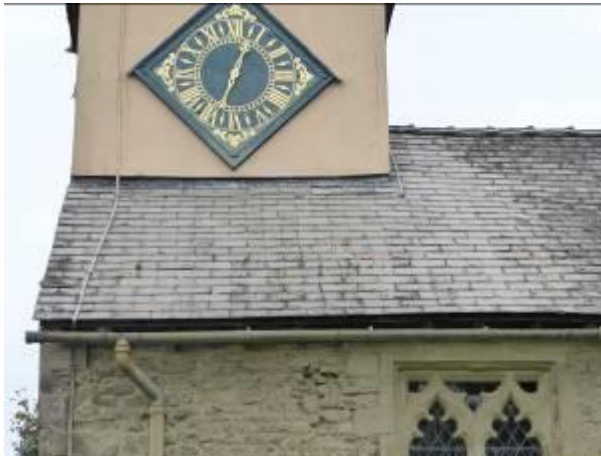
Nave south – Missing slate.

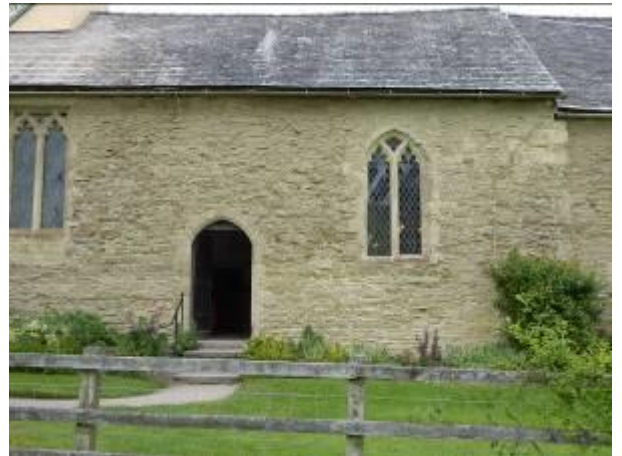
On the south side there is a half round cast iron gutter with single downpipe at the west end. Rust staining to the downpipe indicates possible blockage. This should be checked. Minor deterioration damage to the paintwork. The gutter appears to be poorly aligned with an adverse fall to the east end (away from the downpipe position). This should be checked. There is quite a significant gap between the bottom edge of the slates and the gutter. The efficiency of rainwater collection should be checked here during heavy rainfall. Minor vegetation noted in the gutter at the time of the inspection.

Nave south – Poorly aligned gutter.

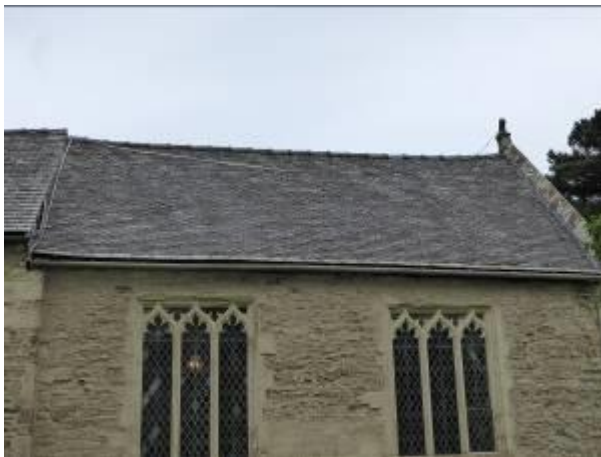
On the south side there is a half round painted cast iron gutter with single downpipe at the east end. Minor surface rust and deterioration of paintwork noted, otherwise sound. The gutter appears to be poorly aligned with an adverse fall to the west end (away from the downpipe position). This should be checked.

Chancel south – Poorly aligned gutter.

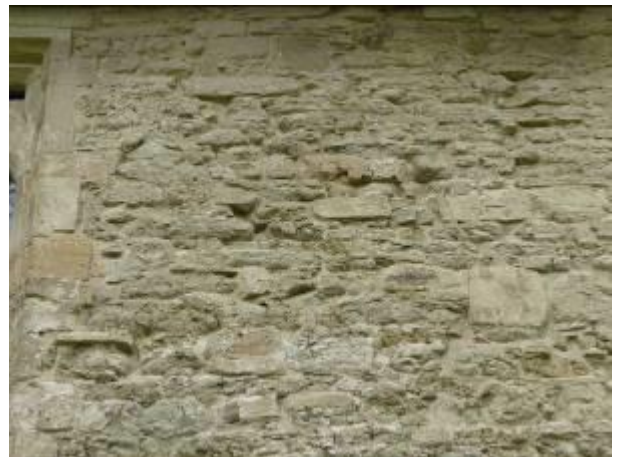
Nave south – Eroding stonework and open joints.

2.2	External Walls – Stonework repairs, repointing and re-application of external limewash shelter coat to chancel and nave south elevations. Minor repairs to nave west gable render and relimewashing.	35,000

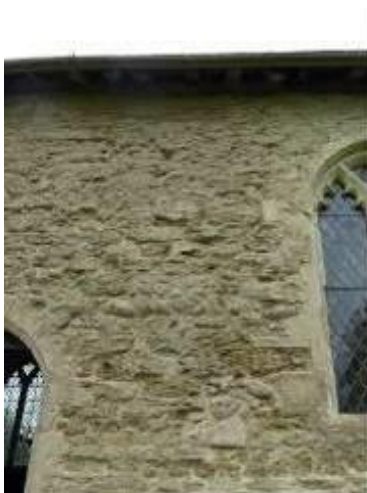
Nave south – Eroding stonework and open joints.

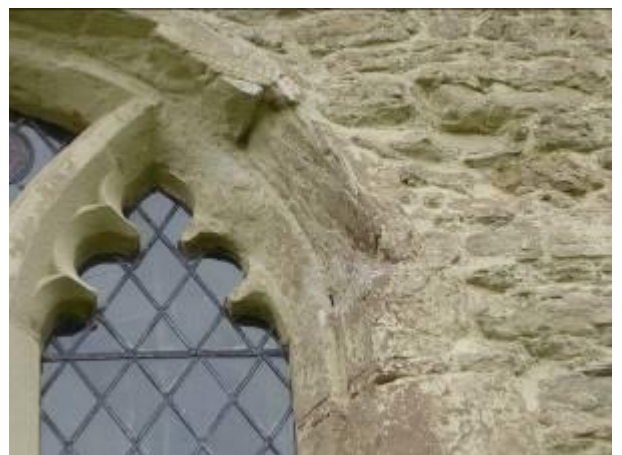
The east window has some heavily weathered stones, particularly one of the voussoirs on the east side. Dressed stone surround to the south doorway is generally sound but with some heavy weathering to a few of the jamb stones. The west window has some ashlar immediately below the cill. The east jambs have some areas of decay.

Nave south, east window – Damaged voussoir.

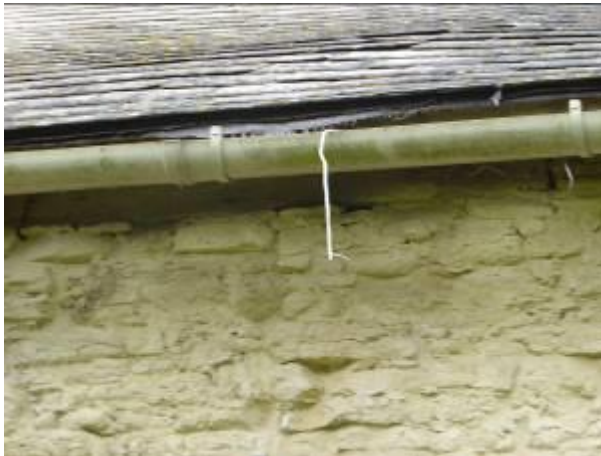
Nave south – Deteriorating roofing felt at eaves.

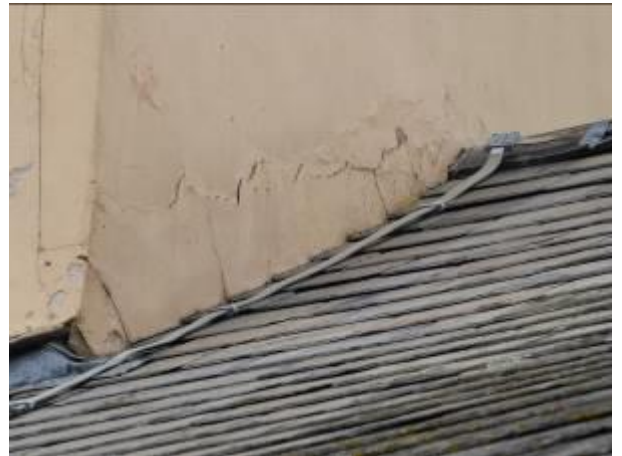
Turret east – Cracking to render over flashings.

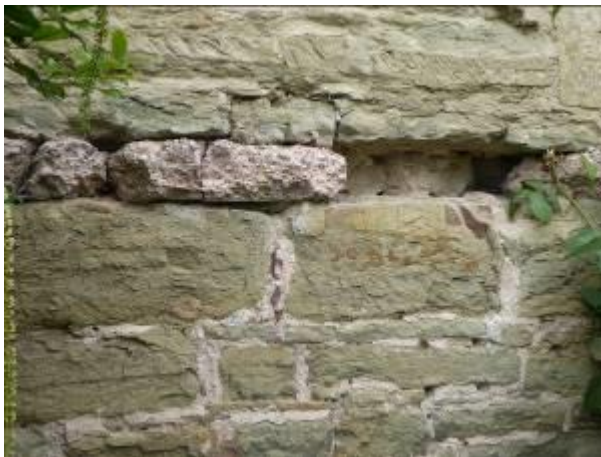
2.2.1 South - Repaired in 2002, including re-pointing and shelter coating with limewash plus some replacement dressed stone (e.g. to the south doorway and the south windows). There are some large voids in the stonework and these should be filled with lime mortar. Most of the limewash has weathered and re-application is recommended to consolidate the eroding stonework. The south door is a timber panelled oak door with a modern yale lock and internal bolts. Decorative strap hinges have surface rust and require treatment/decoration. The decoration to the timberwork is also deteriorating. There is missing pointing mortar between the masonry and the door frame. The PCC has expressed concerns regarding the security of this door (see below).

Nave south – Void in stonework.

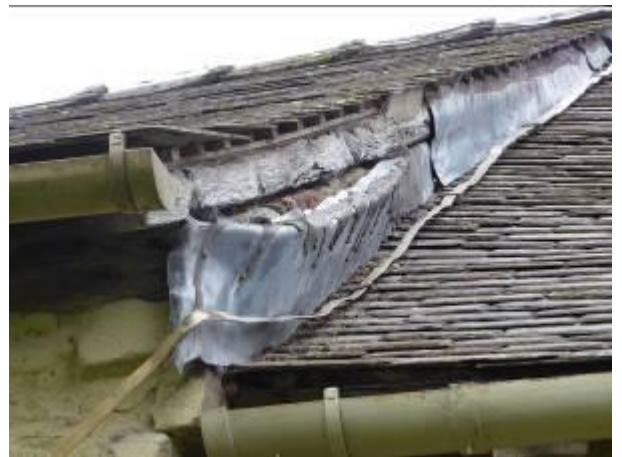
- 4.2 Chancel – The south side is as the Nave south and in similar condition. Visible lead soakers at the east gable parapet abutment appear sound. Cover flashings at the Nave east gable abutment are in poor condition. The lower flashing has come adrift. There is potential for water ingress as well as a fall risk. This should be repaired immediately. The flashing immediately above appears to be oversized but this does not appear to be causing any problems at present.

Chancel – Dislodged flashing at nave east gable abutment.

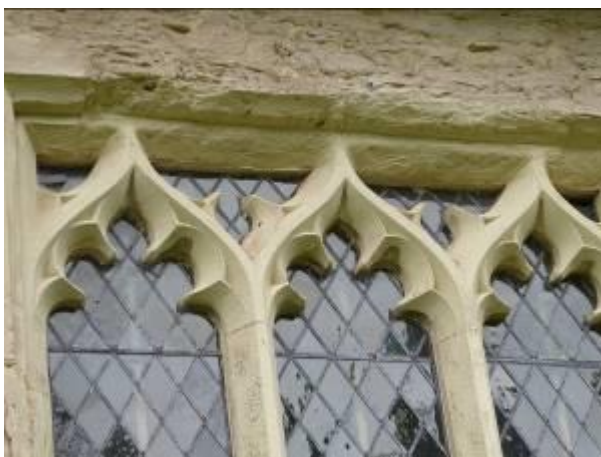
South - Generally in similar condition to the Nave south and similar works are recommended. The head of the east window has some heavy weathering but otherwise the dressed stonework is generally sound. The west window is in similar condition. There are some open joints to the ashlar immediately below the cill. There is a large section of loose and missing stonework at low level (below window cill level) towards the west end.

Chancel south – Damaged stonework to east window.

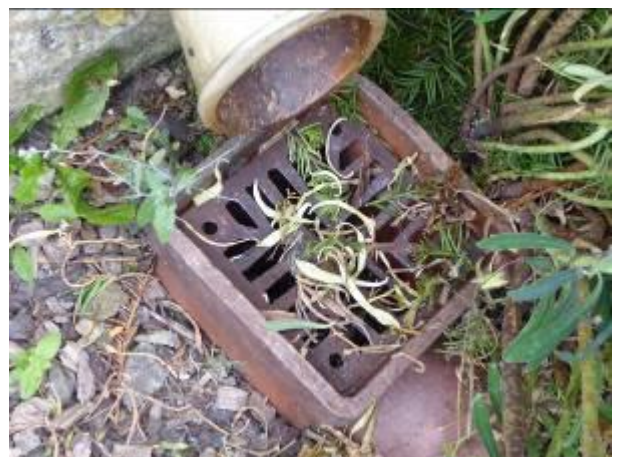
5.4 Surface Water Drainage – Rainwater gulley on the south west corner immediately below the downpipe connected to surface water drainage heading southwards into adjacent parkland. There is no surround to the gulley and one should be provided to ensure rainwater collection is efficient. Rainwater gulley also below the downpipe on the south east corner. This has a brick surround but is damaged and requires some repairs.

Rainwater gully – No surround.

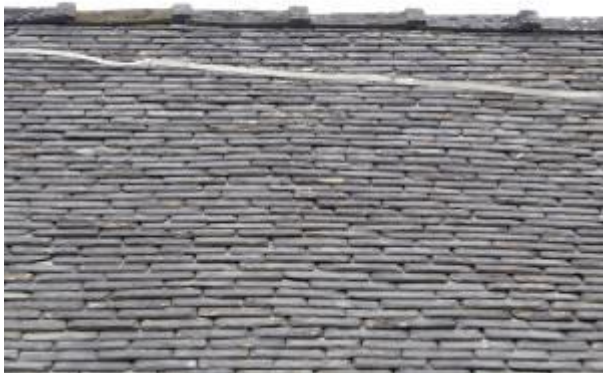
5.1 There is an installation to the Church. It is understood that the installation has not been tested for some time. This should be carried out immediately. The tape to the ridge of the Chancel is loose and requires re-securing.

Lighting conductor – Slipped and dislodged.

1.10	Lightning Conductor – Test, report and resecure.	250
	Total estimated cost	1,250
2.0	Within Eighteen Months	£
2.1	Recasting and relaying of turret roof leadwork and associated repairs.	25,000

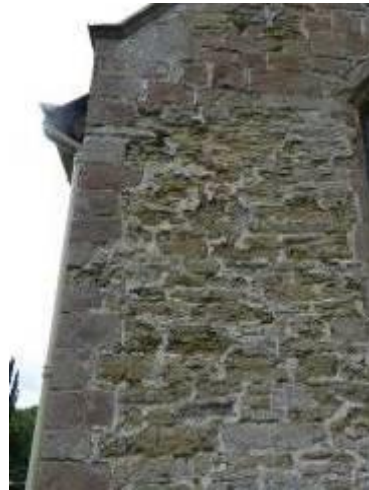
Chancel east gable – Open joints and eroding stonework.

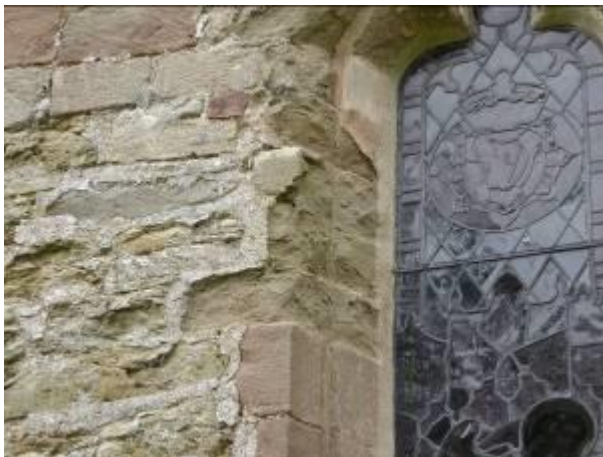
Chancel east gable – Eroding jambs.

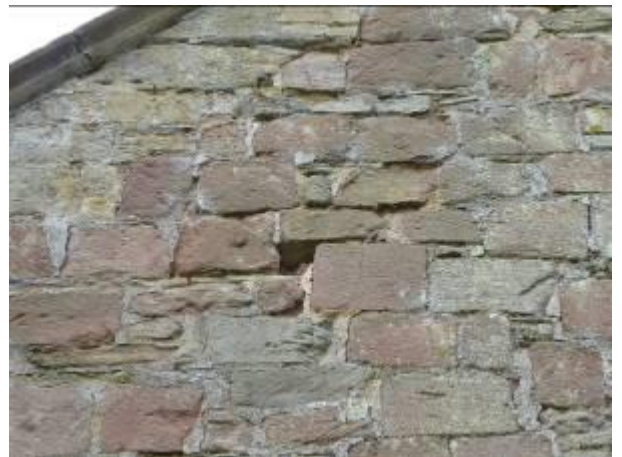
Chancel east gable – Open joints and voids.

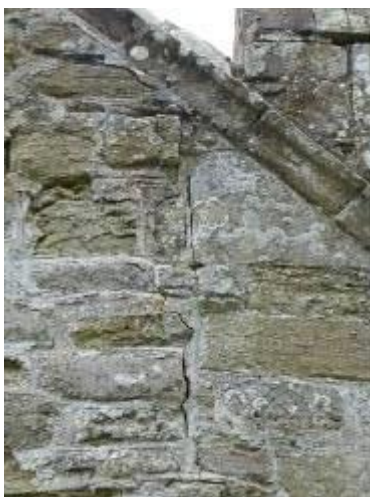
Chancel east gable – Minor movement to north east corner kneeler.

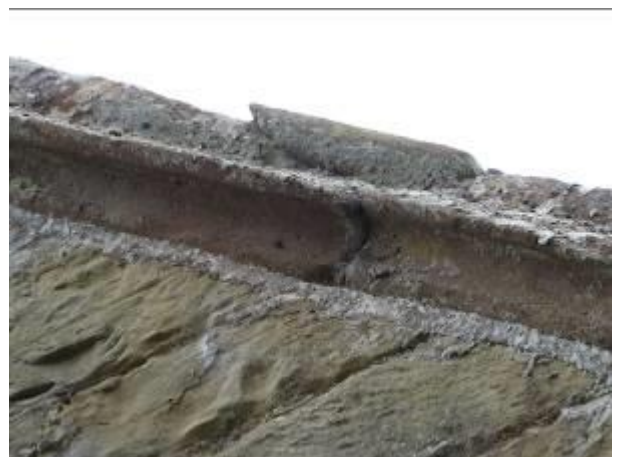
Chancel east gable parapet – Fractured moulding to coping.

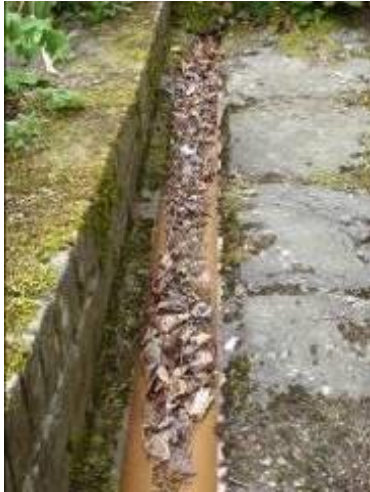
5.6 Perimeter Channel – Half round drainage channel set in concrete on the north and east sides of the Church. Debris in the channel should be removed urgently. Some minor damage and cracking noted to the concrete plus vegetation growth which should be removed. There is also cracking between the edge of the concrete and the

Drainage channel – Debris in channel.

In the short term vegetation growth should be removed and all cracks/joints re-pointed. In the longer term the channel should be removed and replaced with a french drain (perforated drainage pipe surrounded by gravel and connected to soakaways) to control low level damp internally (see below).

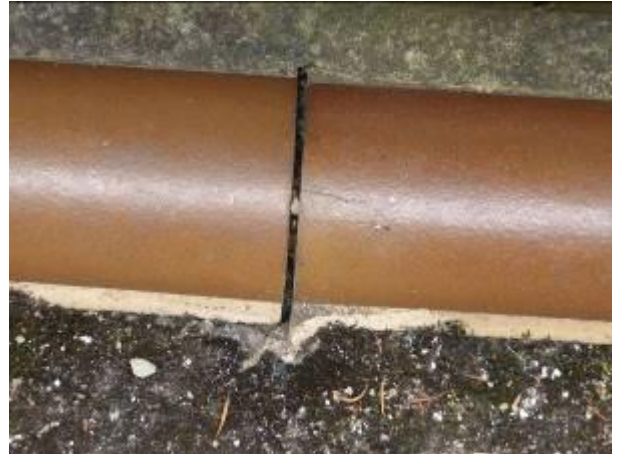
Drainage channel – open joints.

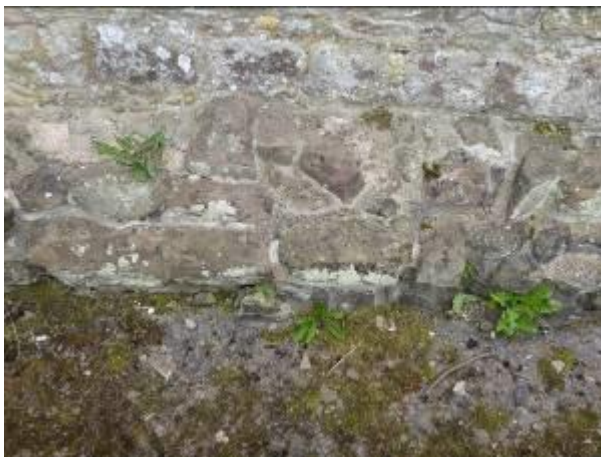
pipe on the north east corner. The channel drains to the south east corner of the Church. Due to the plants and vegetation it is not clear if there is a gully installed. This should be investigated. There appears to be a soakaway installed due south of the Chancel east gable. Brick retaining wall has some open joints and significant surface moss. Weep holes evident. The retaining wall is generally in fair condition.

Drainage channel – Cracking to concrete at junction with external walls.

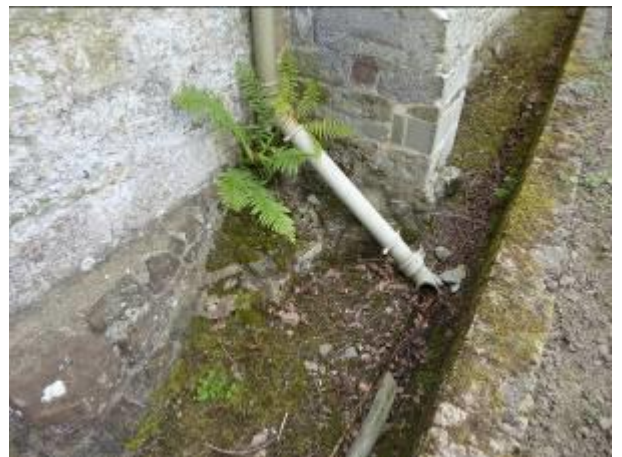
Chancel north – Poor rainwater disposal.

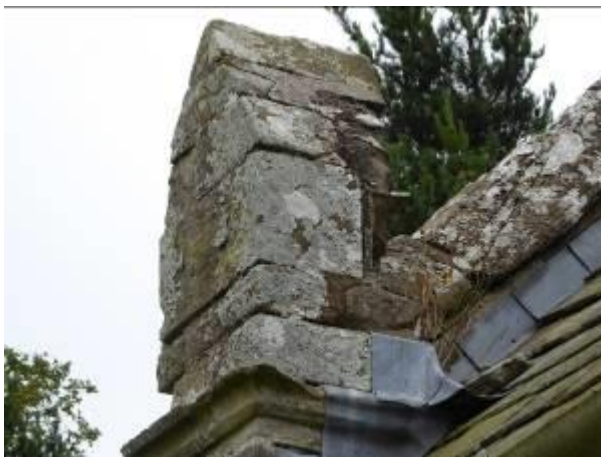
Chancel north east gablet – Open joints and heavily eroded stonework.

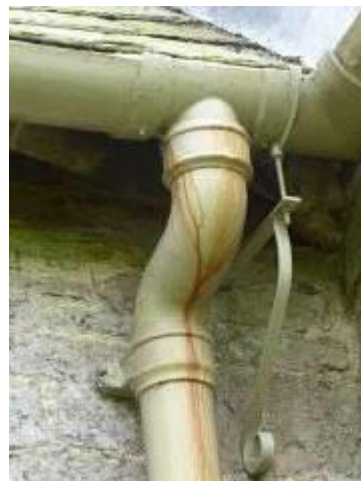
Chancel north – Rust staining to downpipe.

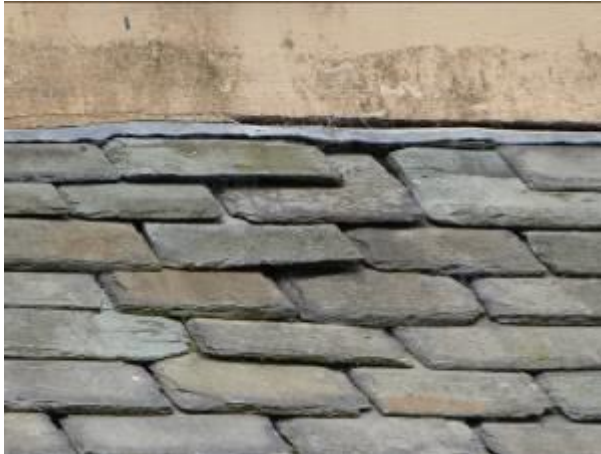
Nave north – Missing slate.

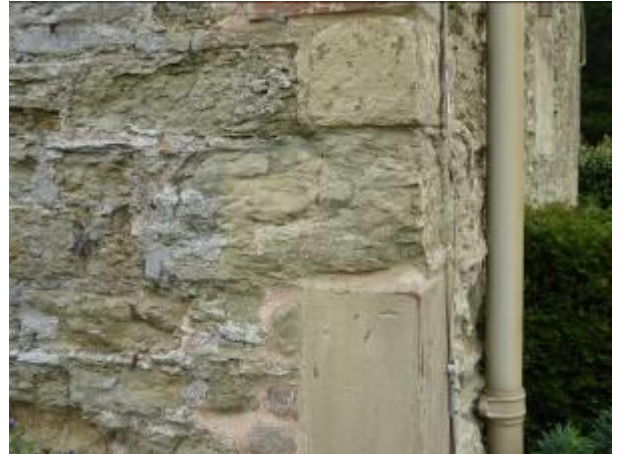
2.2.2 West - The stonework is in similar condition on the south west corner, particularly in the lias areas. Climbing rose bush prevents full inspection but where visible some open joints are noted. One of the quoins on the south west corner is heavily

Nave west gable – Eroding quoins.

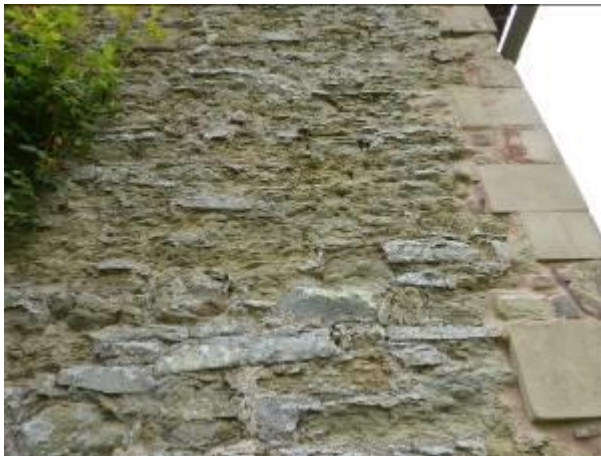
Nave west gable – Eroding stonework.

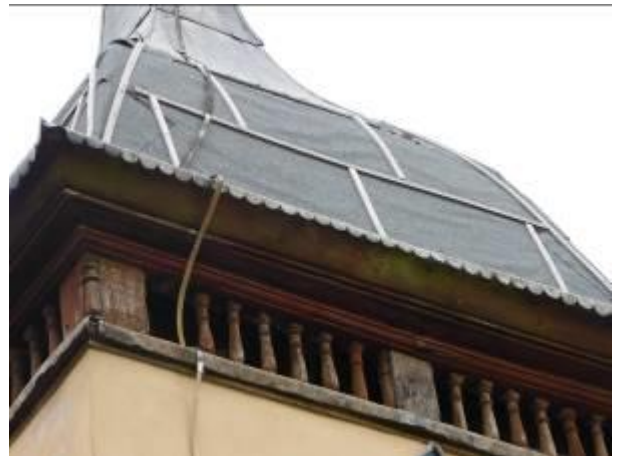
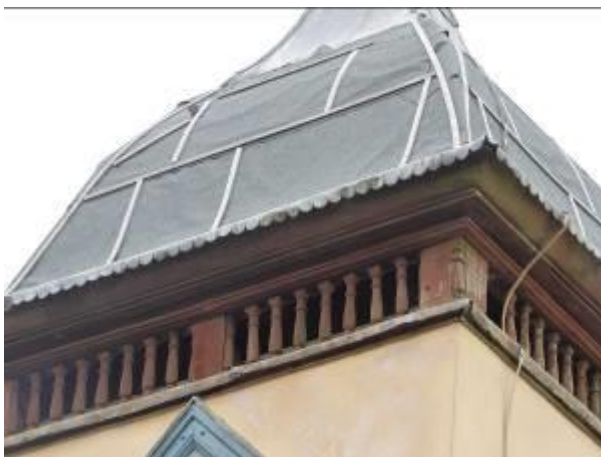
- 3.1 Roof covering – The lead covering to the cupola was removed in 2014 due to severe failure of the fixings and the risk of lead falls. The leadwork at the base of the weathervane and scalloped detail at eaves remains in situ. At present the main roof area is covered with felt and batons as a temporary measure to prevent rainwater ingress. Urgent re-roofing with lead is required. This should be carried out as soon as funding is available.

Turret roof – Temporary felt covering.

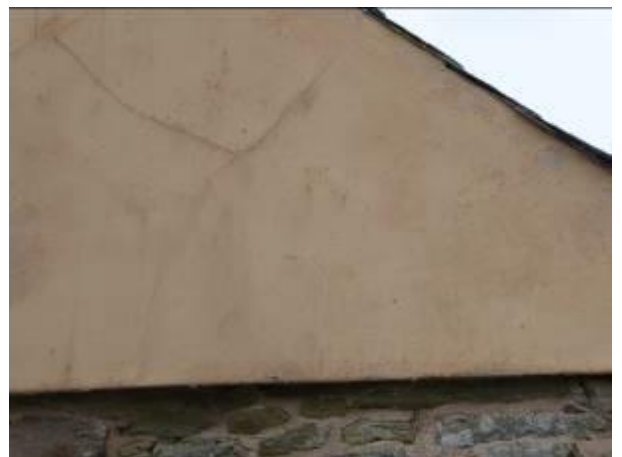
- 3.2 Walls – Limewashed render with some deterioration. Re-limewashing and minor repairs to the render should be carried out when the cupola is re-roofed. Minor cracking noted to the render on the west gable. There is also cracking on the east side at the flashing positions. Above the render there are carved oak balusters and a carved oak cornice. Decorative finish to this is deteriorating. Re-decoration should be carried out when access is available. The painted clock faces on the north and south sides are in fair condition but should be redecorated when access is available.

Nave west gable – Cracking to render.

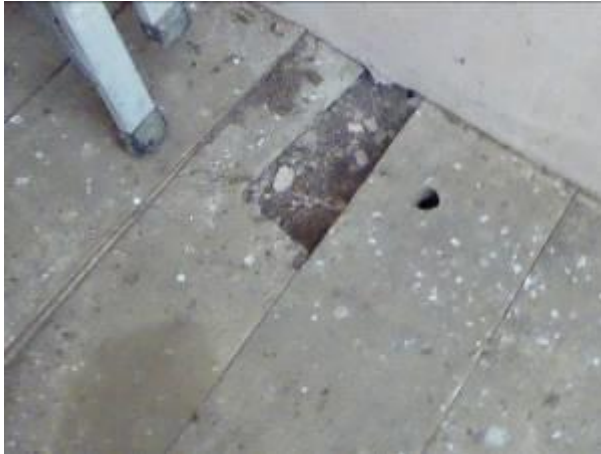
- 2.1.1 First Floor – Boarded timber floor with wide butt jointed boards. Minor damage noted in the north west corner and adjacent to the bell rope guide. Minor repairs are required. Minor debris and bat droppings noted.
- 2.2 Turret Staircase – Timber staircase with wide boards with historic insect activity. Consideration should be given to the provision of a handrail. There appears to be some live insect activity to the timberwork.
- 2.3 Gallery – Wide oak boards with some historic damp staining evident.
- 2.4 Gallery Staircase – As Turret Staircase and in similar condition.

Turret first floor – Decayed and damage to floorboards.

2.3	Turret - Exterior decorations to turret woodwork and clockfaces.	2,500
2.4	Turret first floor – Timber floor repairs.	500
2.5	Internal timberwork – Local treatment.	200

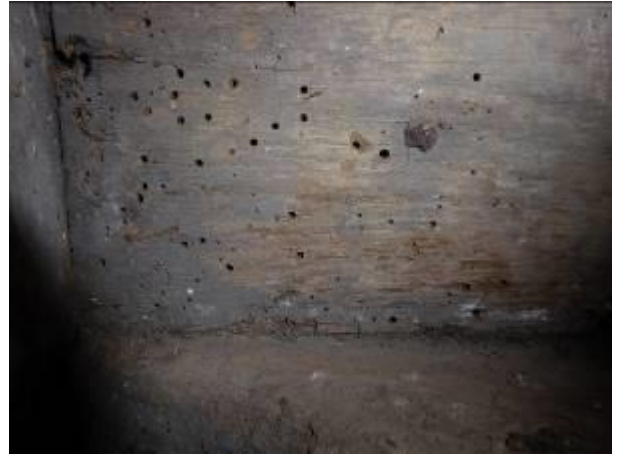
Turret interior – Wood boring insect activity.

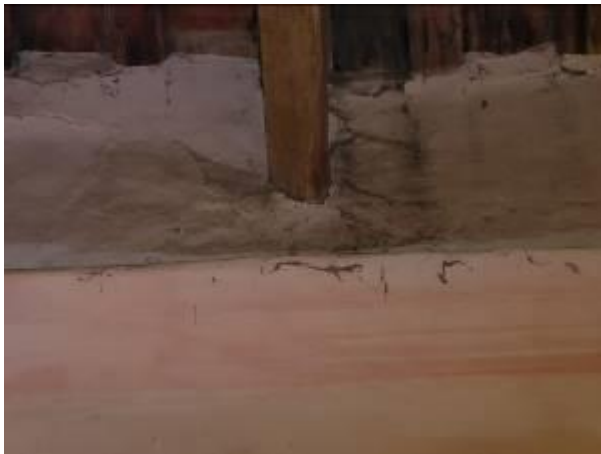
Nave roof – Damaged plaster above moulded cornice.

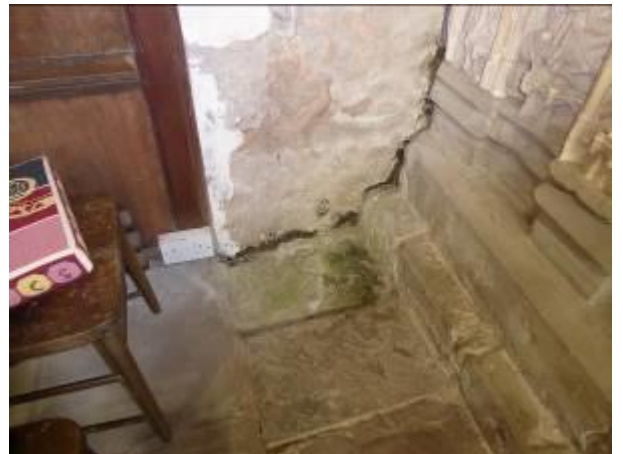
- 3.2 Chancel – Decorative flagstone floor with octagonal and square pattern. Some unevenness and open joints evident. Flagstone area on the north and south sides in good condition with minor open joints only. Low level algae noted in the north east corner adjacent to the Croft monument. Flagstones in Sanctuary area have significant algae. At the altar, the floor is fully carpeted and has a rubber backed underlay. This should be removed as this can cause damp problems internally.

Chancel floor – Algae and damp.

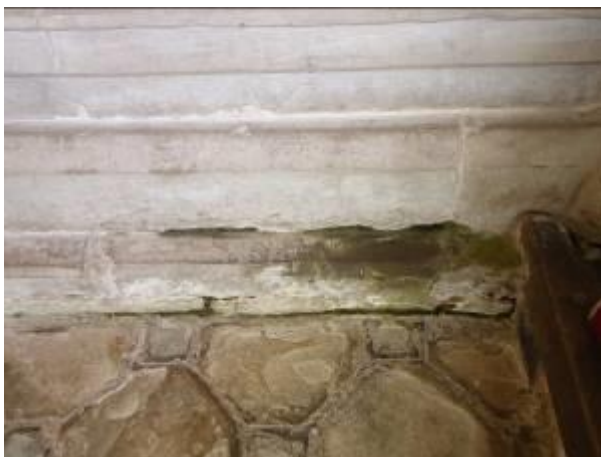
Chancel wall – Algae and damp.

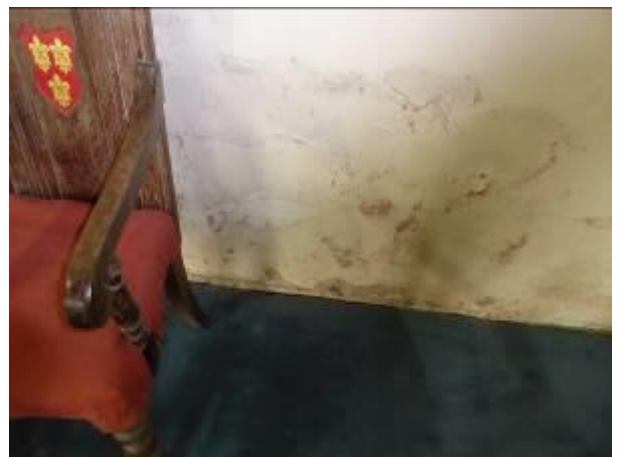
Chancel wall – Algae and damp.
